Muirfield HOA

Level 2 Reserve Study

Report Period – 01/01/2021 – 12/31/2021

Type of Study	Update w/Site Visit
Date of Property Inspection	4/20/2020
Prepared By	Dale Gifford
Analysis Method	Cash Flow
Funding Goal	Full Funding

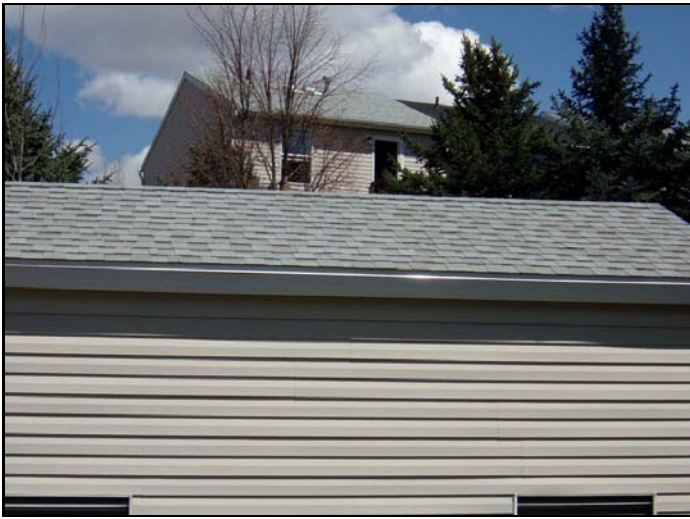
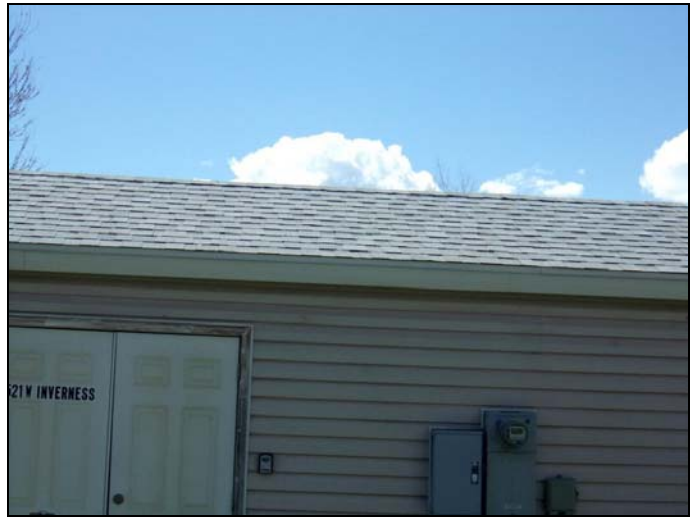
Comp #: 105 Pump House Roof - Replace

The roof is in good condition. We recommend funding to replace this component approximately every 20 - 25 years. Remaining life based on current age.

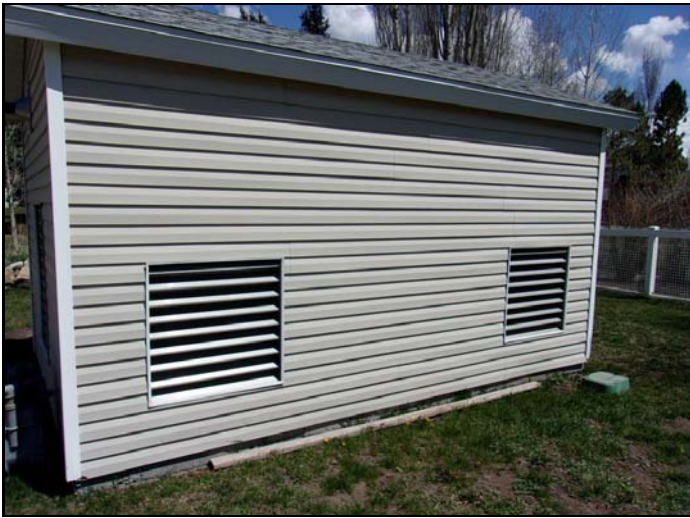
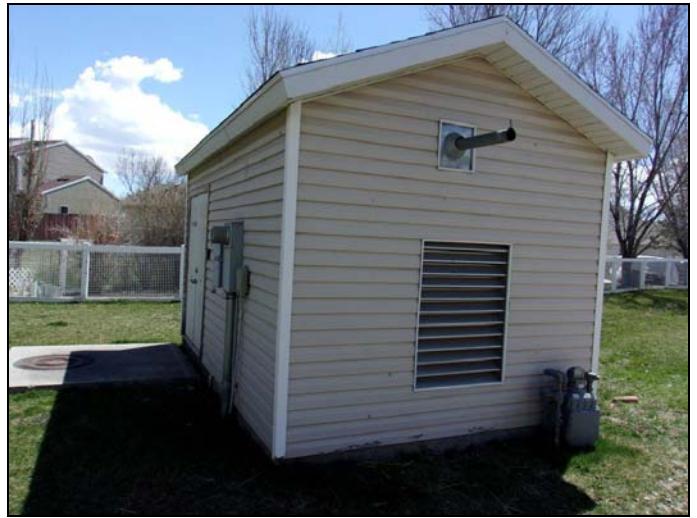
Comp #: 302 Vinyl Siding - Replace

The vinyl siding is in good to fair condition. We recommend funding to replace this component approximately every 40 - 50 years. Remaining life based on current age.

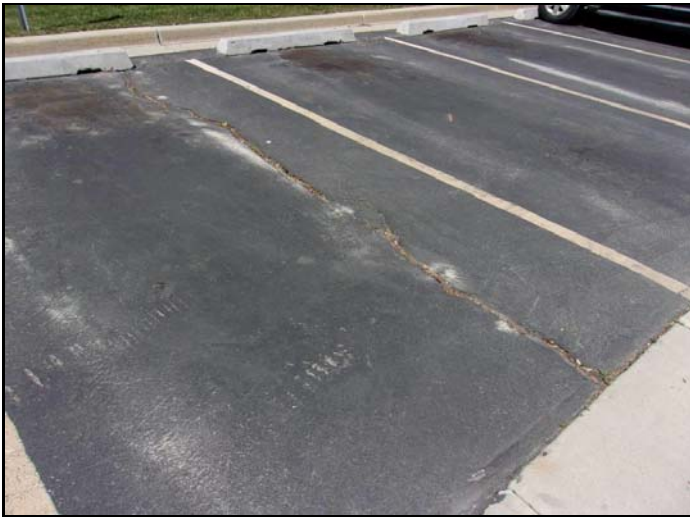
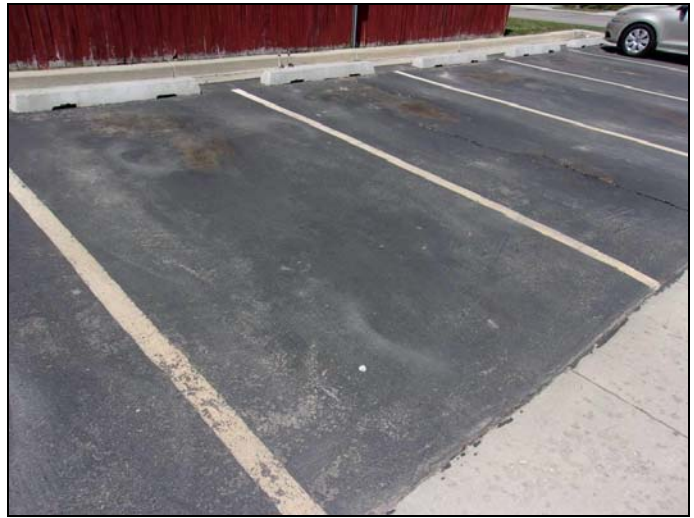
Comp #: 401 Asphalt - Major Rehab

The asphalt surfaces are in good condition. We recommend funding for a major rehab of this component approximately every 25 - 30 years. Remaining life based on current condition.

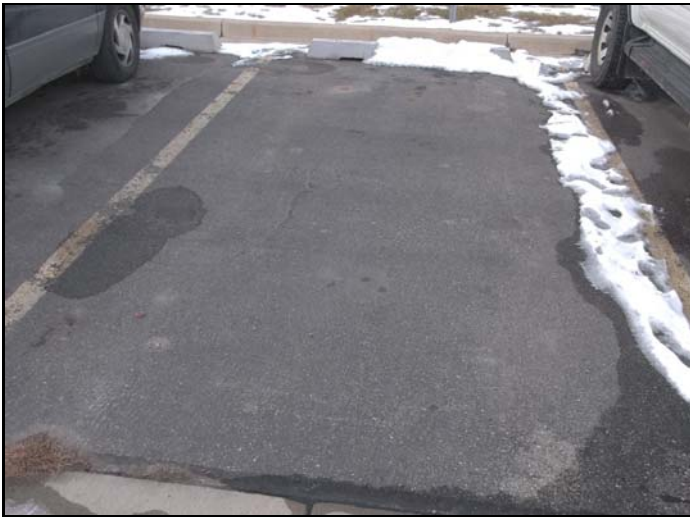
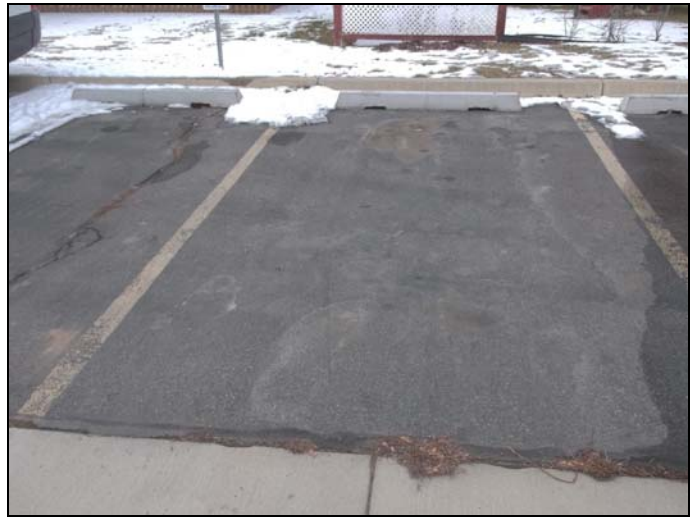
Comp #: 402 Asphalt - Seal Coat

Research with the client reveals this component will be sealed 2021. We recommend funding to seal this component approximately every 3 - 5 years. Remaining life based on current age.

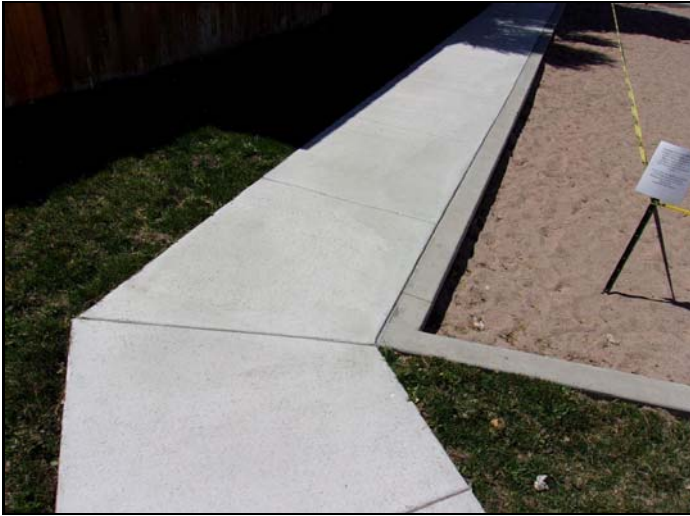
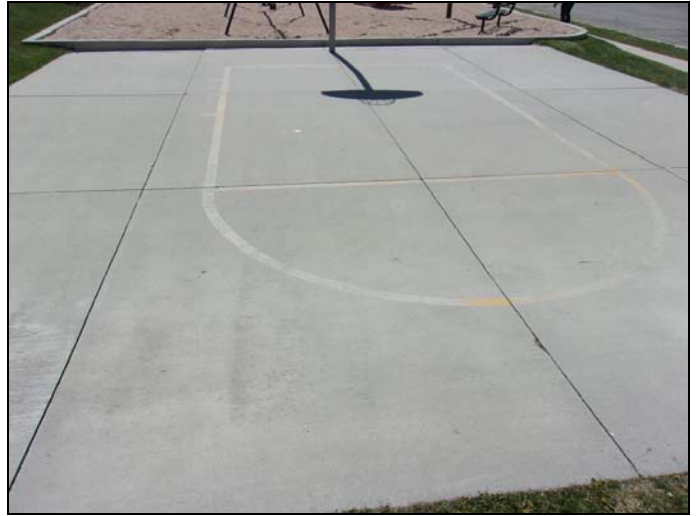
Comp #: 403 Concrete - Repair/Replace

The concrete is in good condition. This component has an extended useful life under normal conditions. We recommend funding to make repairs and partially replace this component approximately every 10 years. Remaining life based on current age.

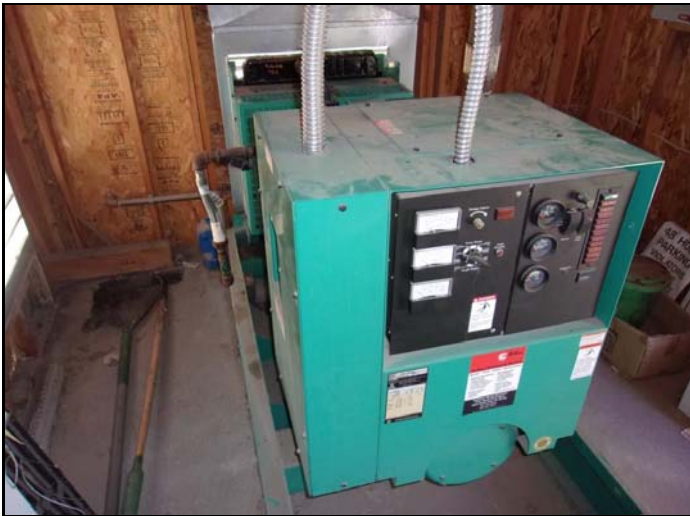
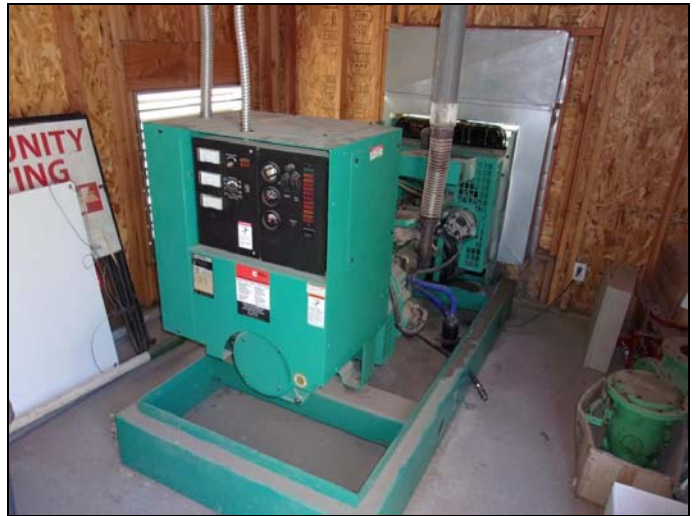
Comp #: 710 Emergency Generator - Replace

According to the Client the emergency generator is in working condition. Due to minimal use this component has a relatively long life. However we recommend funding to replace this generator approximately every 25 years to ensure the availability of parts and to keep up with modern technology and emission requirements. Perform twice yearly maintenance and weekly exercise program to ensure full life from this component. Remaining life based on current age

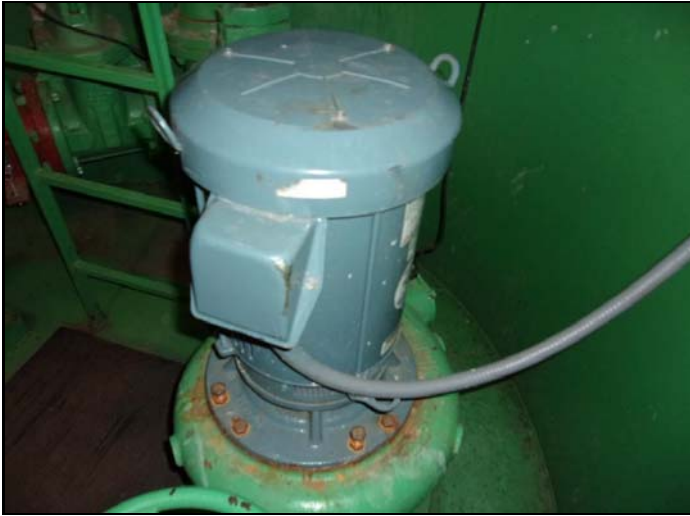
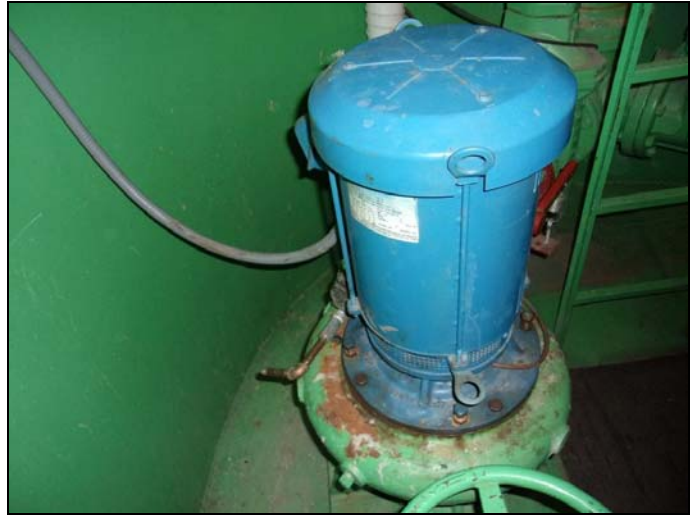
Comp #: 715 Pumps - Replace

The pumps are in working condition. We recommend funding to replace this component approximately every 10 - 15 years. Remaining life based on current age.

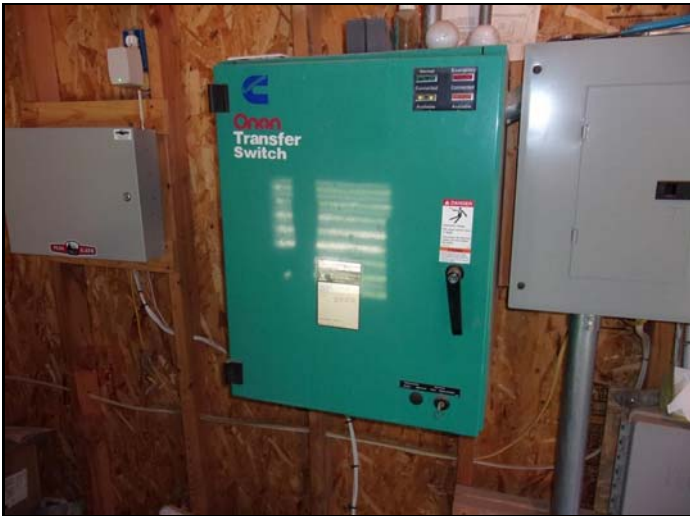
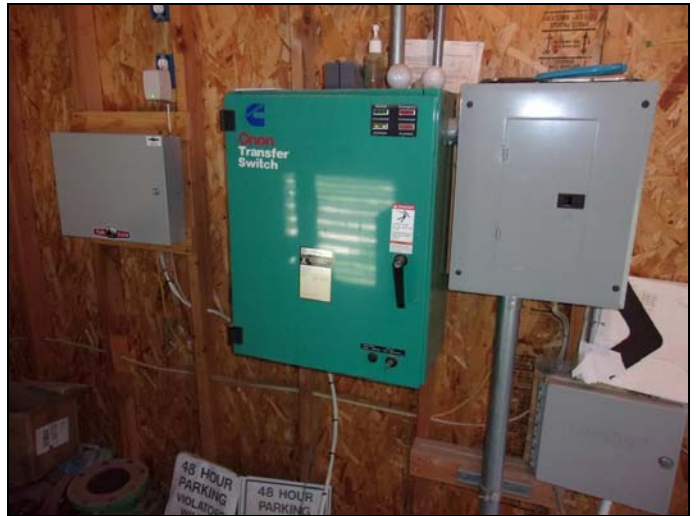
Comp #: 790 Generator Transfer Switch - Replace

The generator transfer switch is in working condition. We recommend funding to replace this component approximately every 20 - 25 years. Remaining life based on current age.

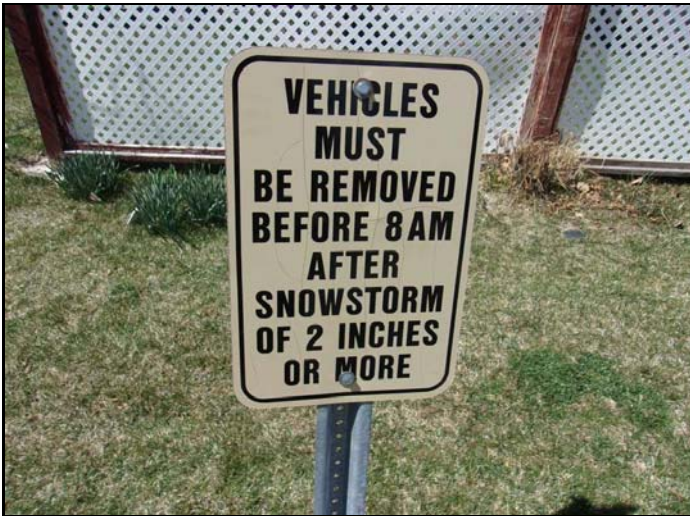
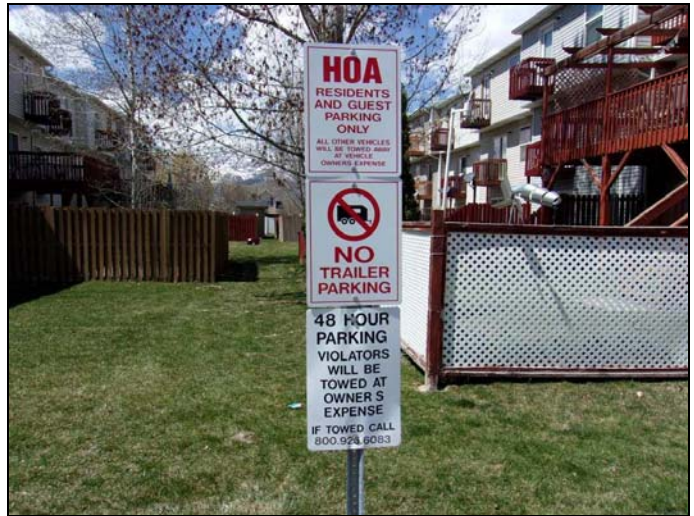
Comp #: 808 Parking Signs - Replace

Research with the client. Although this component may have an extended useful life, the client has requested this be included in the reserve study every 7 years. Remaining life based on current age.

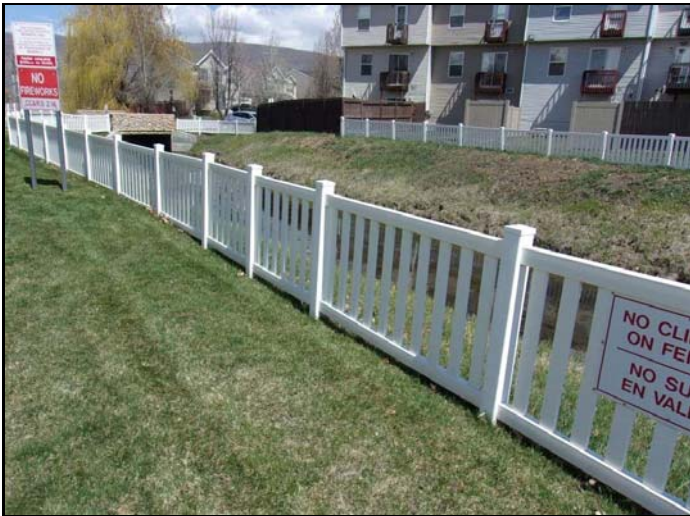
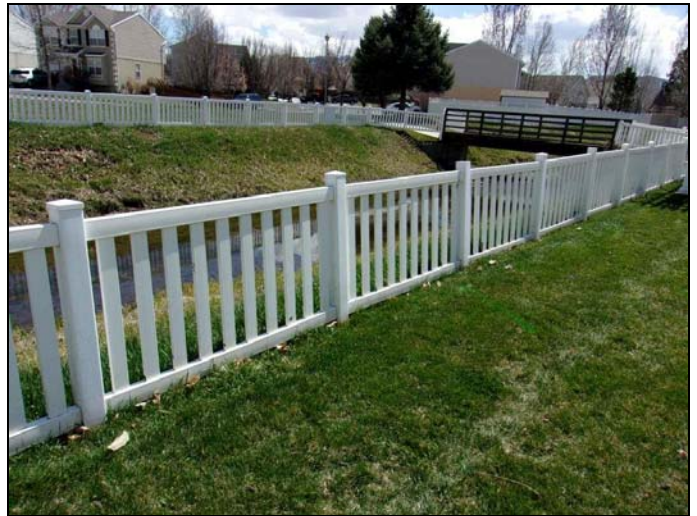
Comp #: 1008 Vinyl Fencing - Replace

The vinyl fencing is in good condition. We recommend funding to replace this component approximately every 25 - 30 years. Remaining life based on current age.

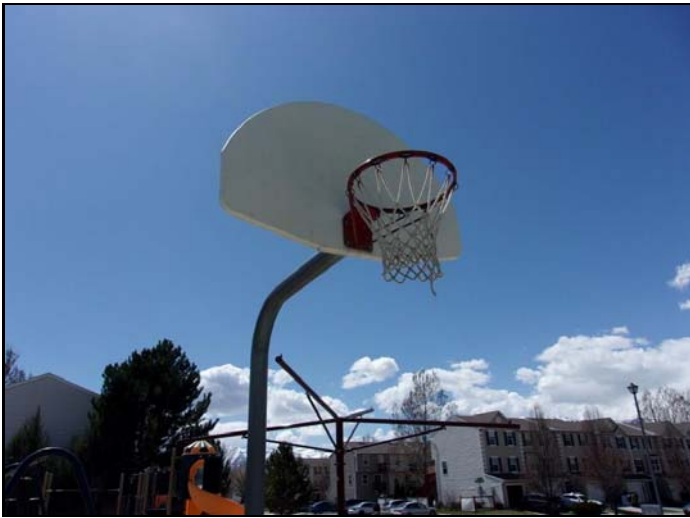
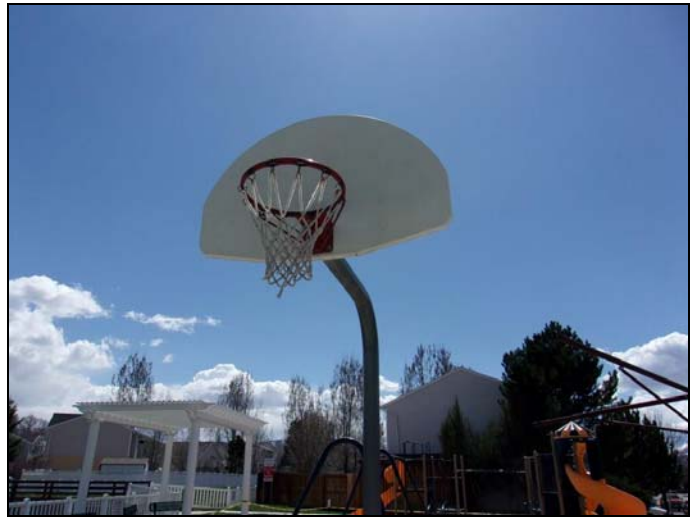
Comp #: 1207 Basketball Equipment - Replace

The basketball equipment is in fair condition. We recommend funding to replace this component approximately every 10 - 15 years. Remaining life is based on current condition.

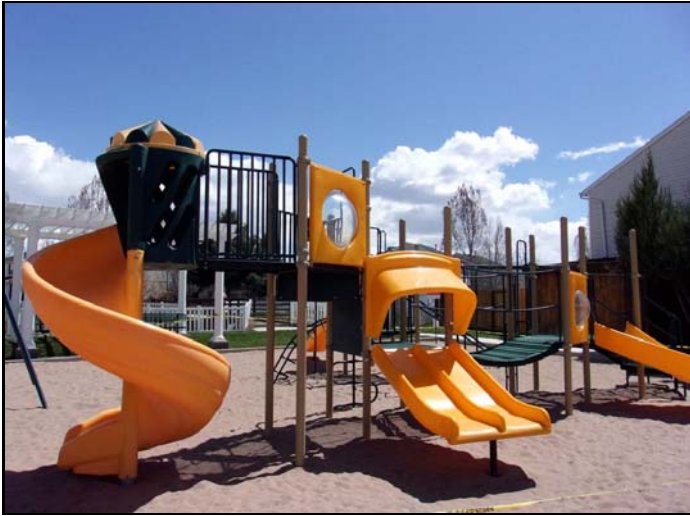
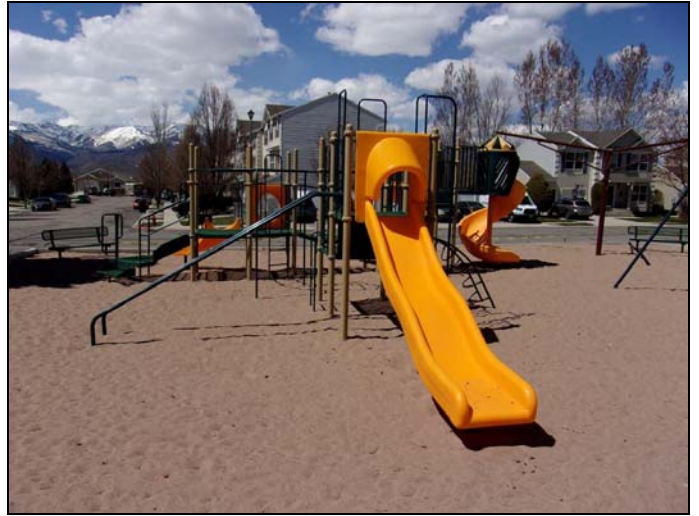
Comp #: 1301 Play Structure - Replace

The play structure is in good condition. We recommend funding to replace this component approximately every 20 - 25 years. Remaining life based on current condition.

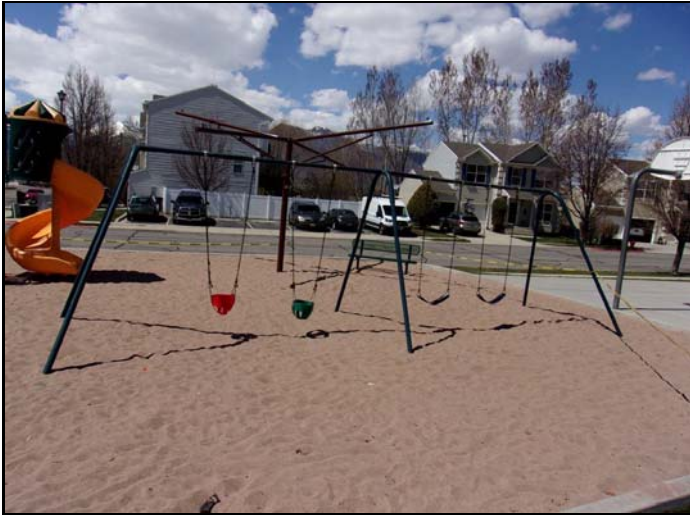
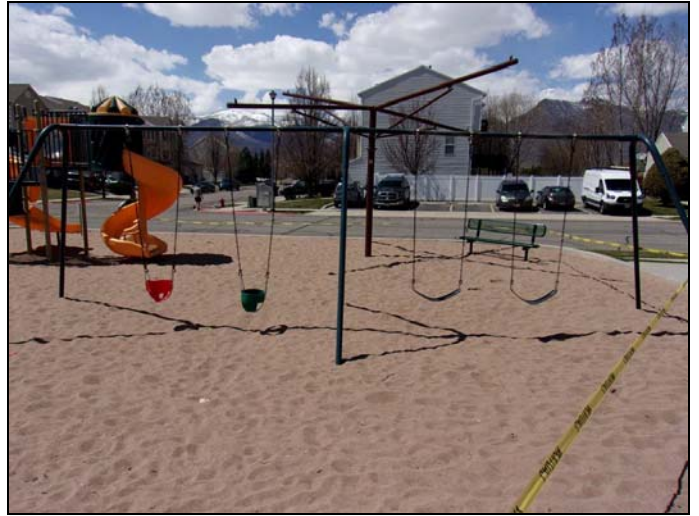
Comp #: 1302 Swing Set - Replace

The swing set is in good condition. We recommend funding to replace this component every 30 - 40 years. Remaining life based on current age.

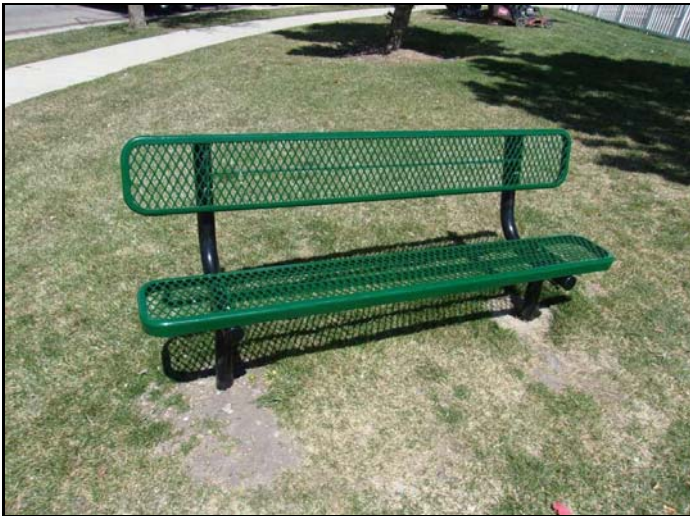
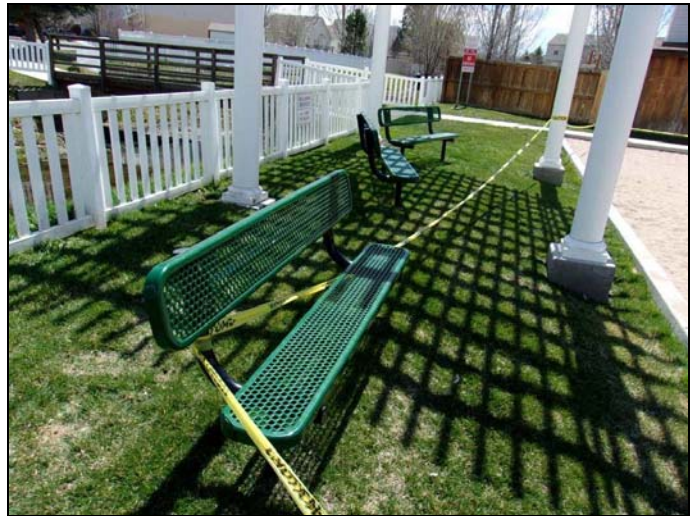
Comp #: 1307 Benches - Replace

The benches are in good condition. We recommend funding to replace this component approximately every 10 - 15 years. Remaining life based on current age.

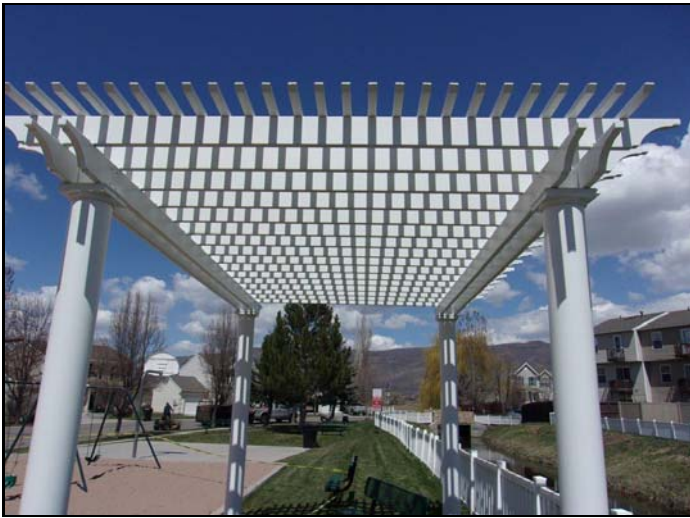
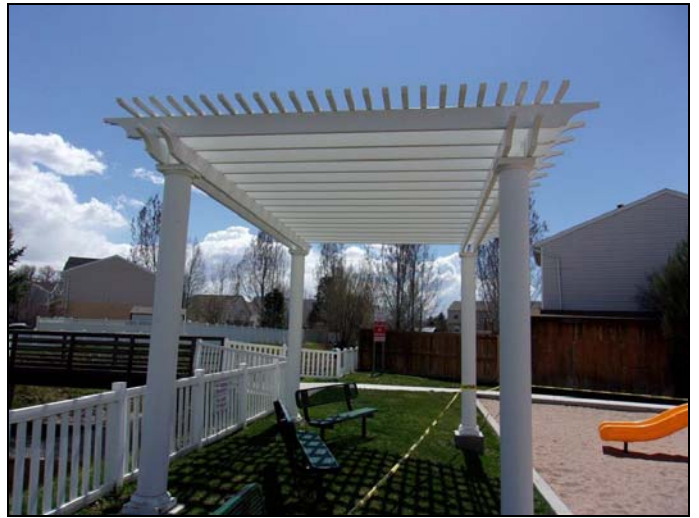
Comp #: 1309 Pergola - Replace

The pergola is in good condition. We recommend funding to replace this component approximately every 25 - 30 years. Remaining life based on current age.

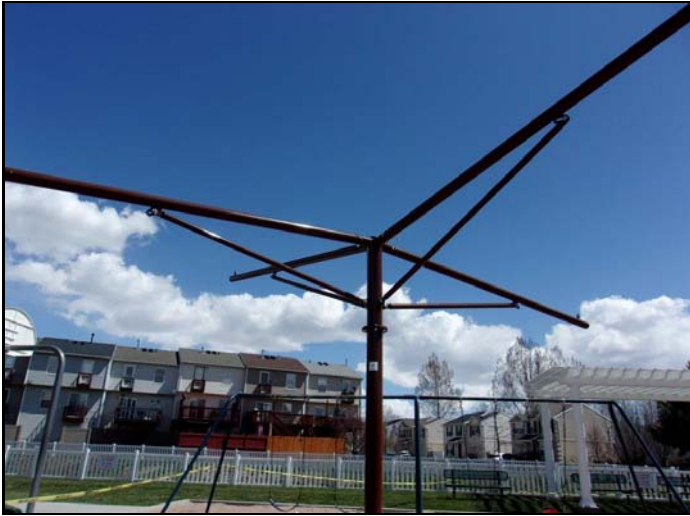
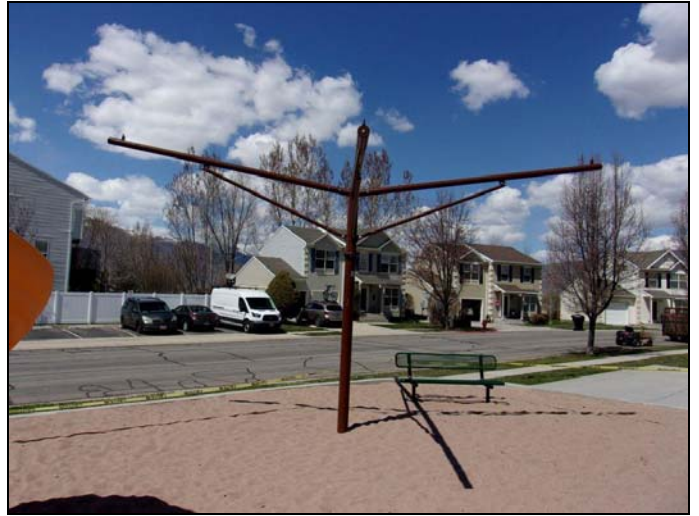
Comp #: 1310 Shade Structure Fabric - Replace

Unable to inspect this component at the time of the site visit. We recommend funding to replace this component approximately every 10 years. Remaining life based on current age.

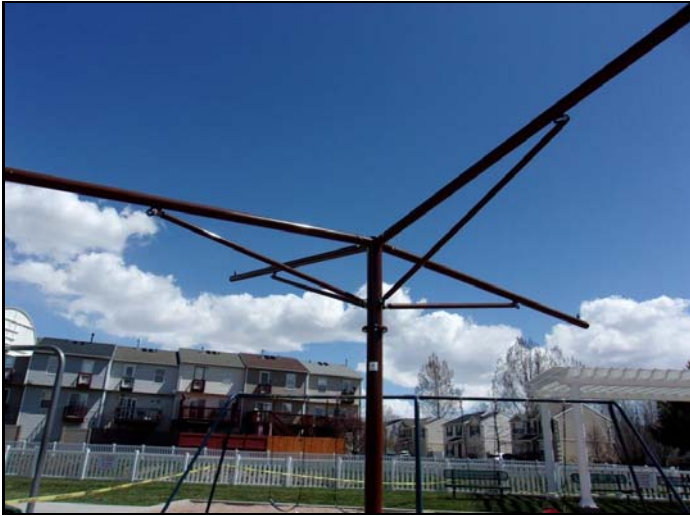
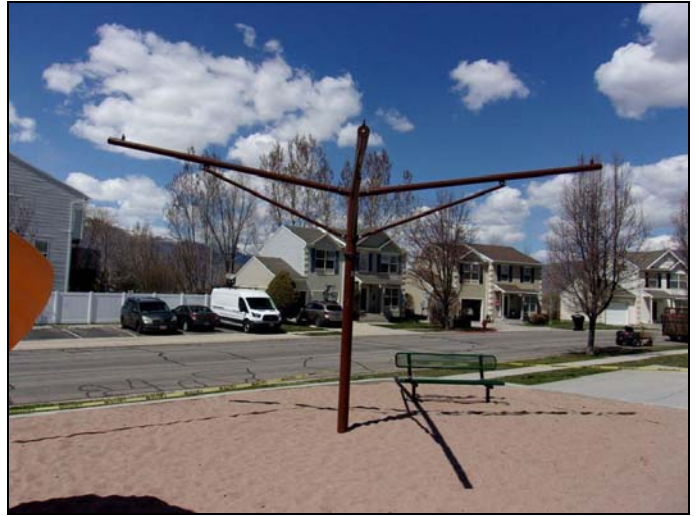
Comp #: 1311 Shade Structure - Replace

The shade structure is in good condition. We recommend funding to replace this component approximately every 25 - 30 years. Remaining life based on current age.

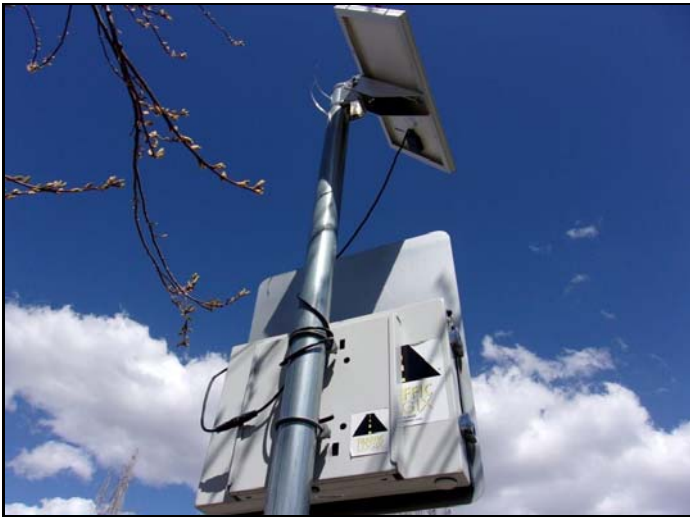
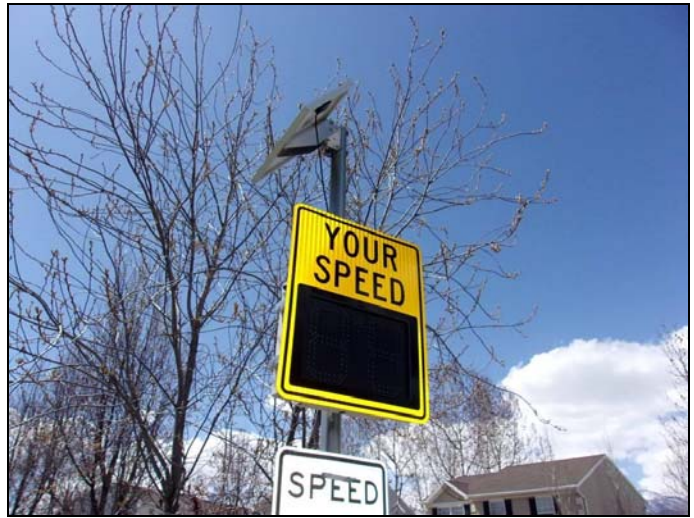
Comp #: 1312 Solar Speed Signs - Replace

The speed signs are in good condition. We recommend funding to replace this component approximately every 12 - 15 years. Remaining life based on current age.

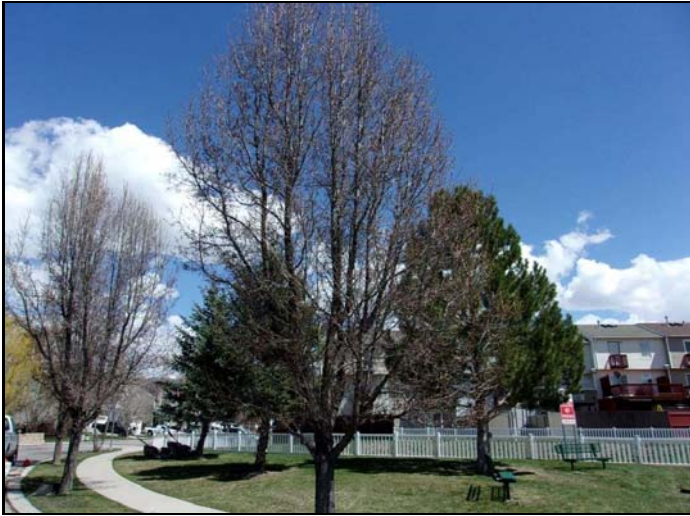
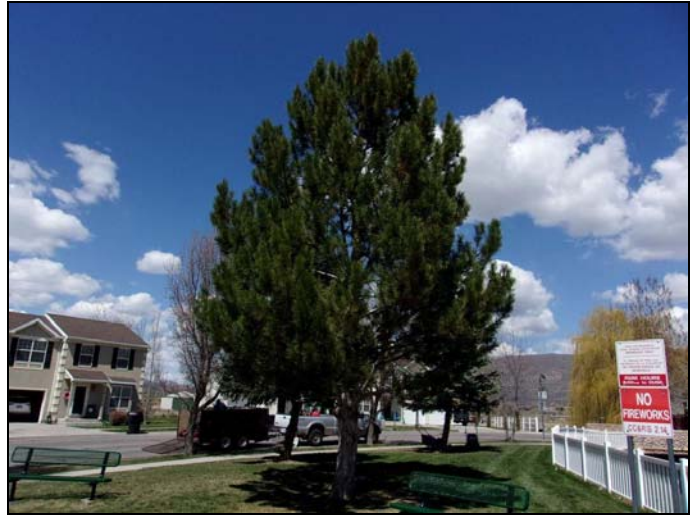
Comp #: 1802 Tree - Maintenance

Research with the client reveals this component will be maintained in 2023. The client reveals plans to trim and make replacements to this component approximately every 3 years. Remaining life based on current age.

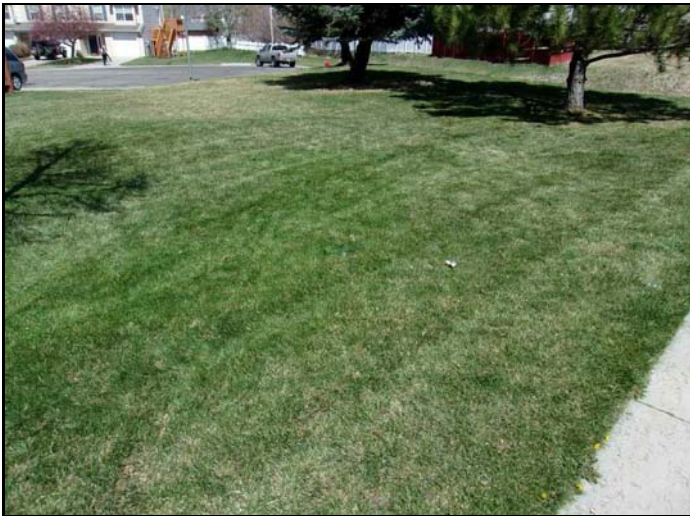
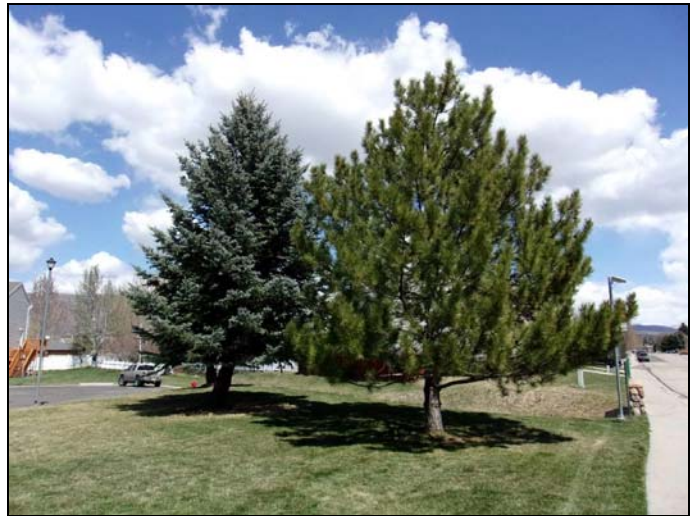
Comp #: 1812 Landscaping & Irrigation System - Renovate

The landscaping and irrigation system are in generally good condition. We recommend funding for an allowance to renovate the landscaping and irrigation system approximately every 20 years. Remaining life based on current age.

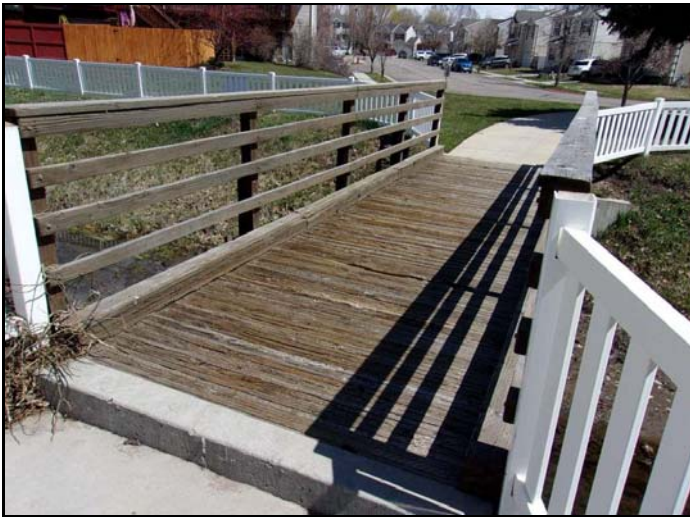
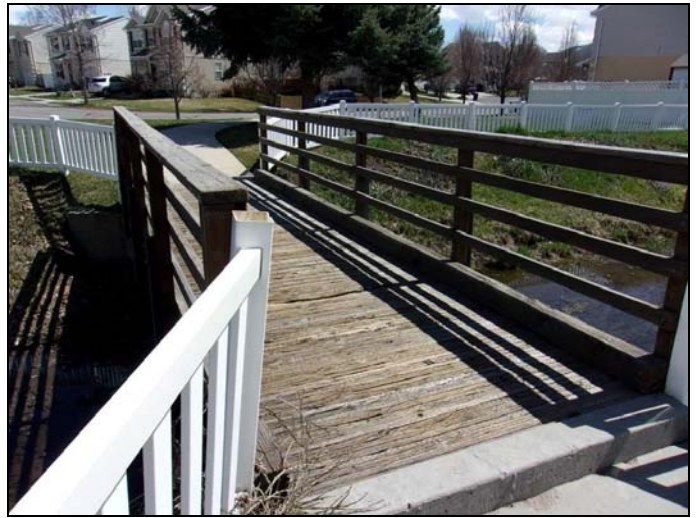
Comp #: 2302 Pedestrian Bridge - Playground - Replace

The bridge appears to be in good condition. We recommend funding to rebuild the bridge approximately every 25 - 30 years. Remaining life based on current age.
